DEPARTMENT OF TRANSPORTATION**DIVISION OF ENGINEERING SERVICES**

Quality Assurance and Source Inspection

Contract #: 04-0120F4Cty: SF/ALA Rte: 80 PM: 13.2/13.9File #: 1.28**WELDING INSPECTION REPORT****Resident Engineer:** Siegenthaler, Peter**Address:** 333 Burma Road**City:** Oakland, CA 94607**Report No:** WIR-016927**Date Inspected:** 24-Sep-2010**Project Name:** SAS Superstructure**OSM Arrival Time:** 630**Prime Contractor:** American Bridge/Fluor Enterprises, a JV**OSM Departure Time:** 1500**Contractor:** American Bridge/Fluor Enterprises, a JV**Location:** Jobsite**CWI Name:** See below**CWI Present:** Yes No**Inspected CWI report:** Yes No N/A**Rod Oven in Use:** Yes No N/A**Electrode to specification:** Yes No N/A**Weld Procedures Followed:** Yes No N/A**Qualified Welders:** Yes No N/A**Verified Joint Fit-up:** Yes No N/A**Approved Drawings:** Yes No N/A**Approved WPS:** Yes No N/A**Delayed / Cancelled:** Yes No N/A**Bridge No:** 34-0006**Component:** SAS OBG**Summary of Items Observed:**

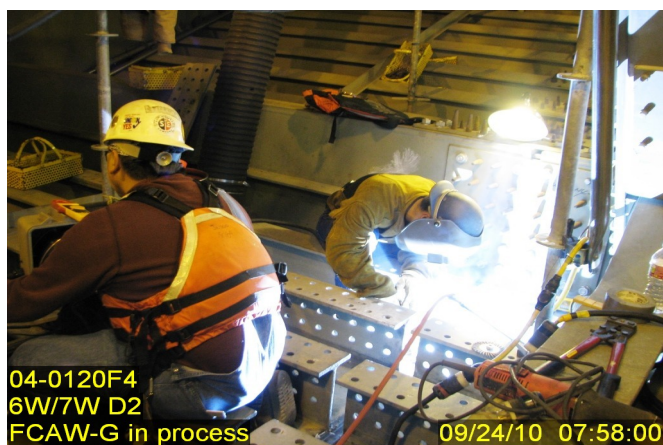
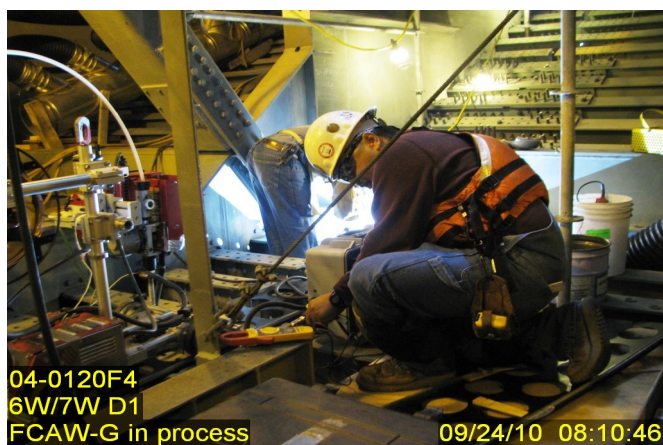
The QAI periodically observed AB/F welder Xiao Jian Wan (ID 9677) performing welding per the Flux Cored Arc Welding (FCAW-G) process in the 1G (flat) to weld fill and cover passes. See photo below. Mr. Xiao Jian Wan

was welding the first 300mm of weld D1 adjacent to the counterweight side longitudinal diaphragm. QC Inspector Jesse Cayabyab was present to monitor the progress and verify that the welding parameters were within the limits established by the approved welding Procedure Specification (WPS) identified as ABF-WPS-D1.5-3040A-1.

Welding was completed at this location and work appeared to be in general compliance with contract documents.
